Manhole Inspection Summary

Manhole # S15EE2013MH

Insp Date: **7/13/06 8:52 AM**

Location Address: **2100 WESTERN RUN DR**

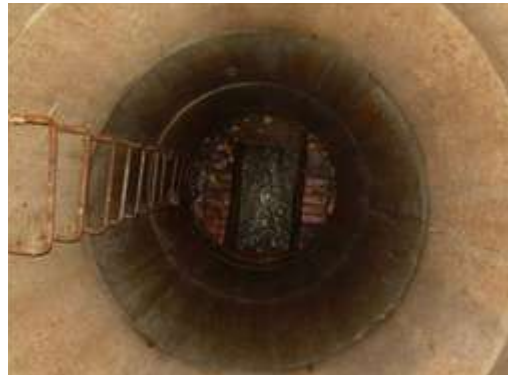
Top View

Barrel infiltration. Evidence of surcharge - Bench debris.

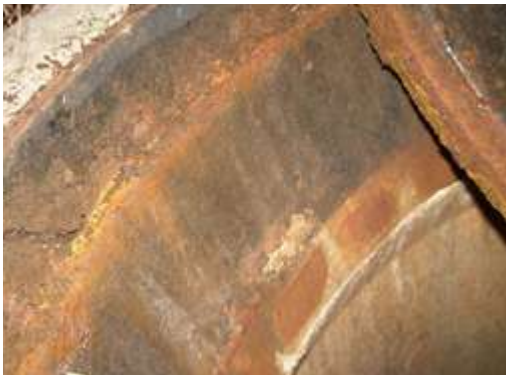
Defect

☒ **Leaks**

Frame leaks. Adjustment and Corbel infiltration.

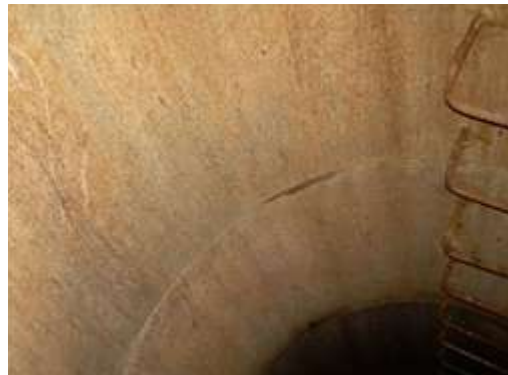
Defect

infiltration in mh

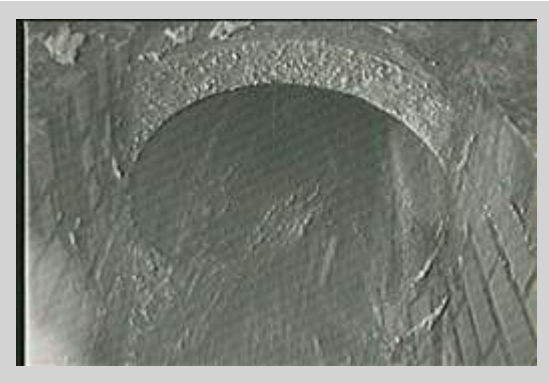
24 in. Circular Gravity Sewer Pipe Out @ 12 O'Clock

Infiltration: **None** Pipe Seal Cond: **Unknown**

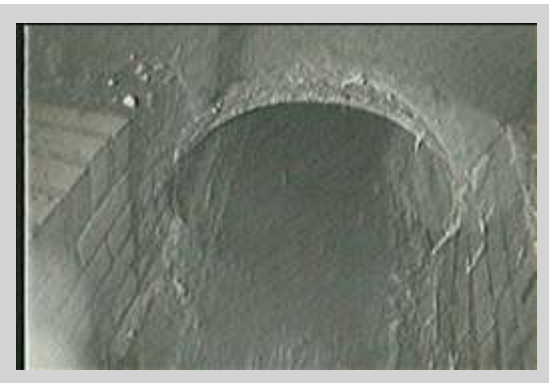
24 in. Circular Gravity Sewer Pipe In @ 6 O'Clock

Infiltration: **None** Pipe Seal Cond: **Unknown**
